# A Sinking Feeling

## Collapsed Pipe, Deplorable Manholes Put EIPI to the Test

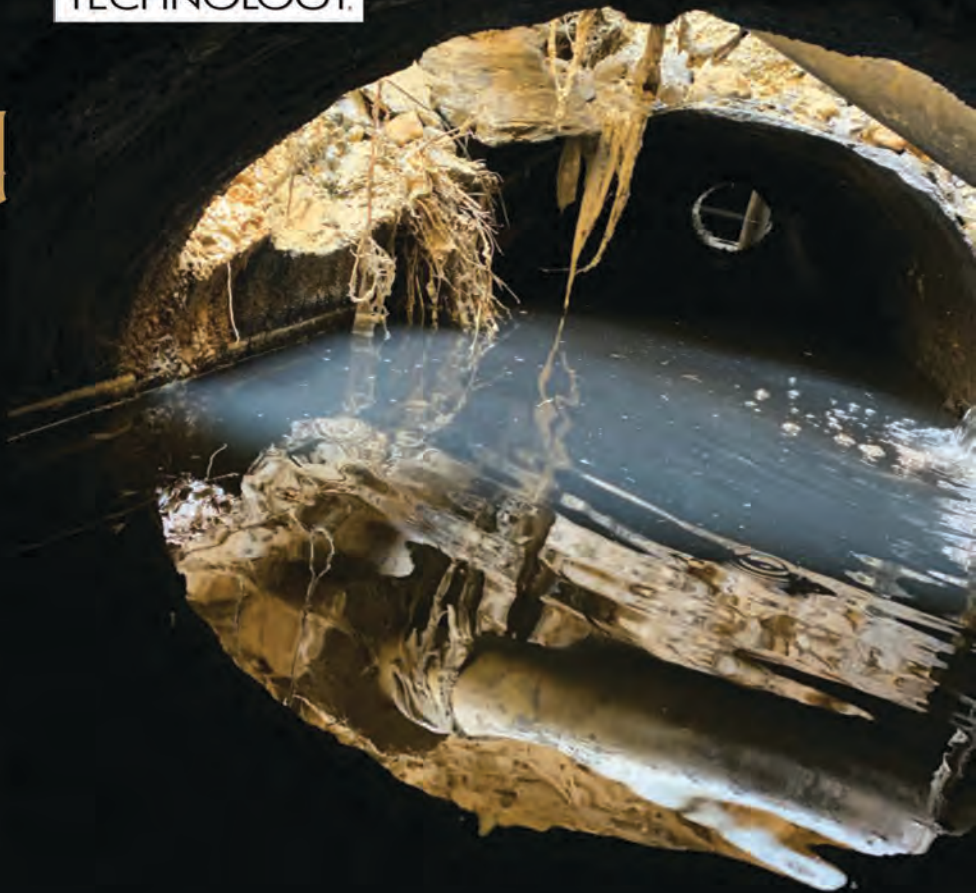
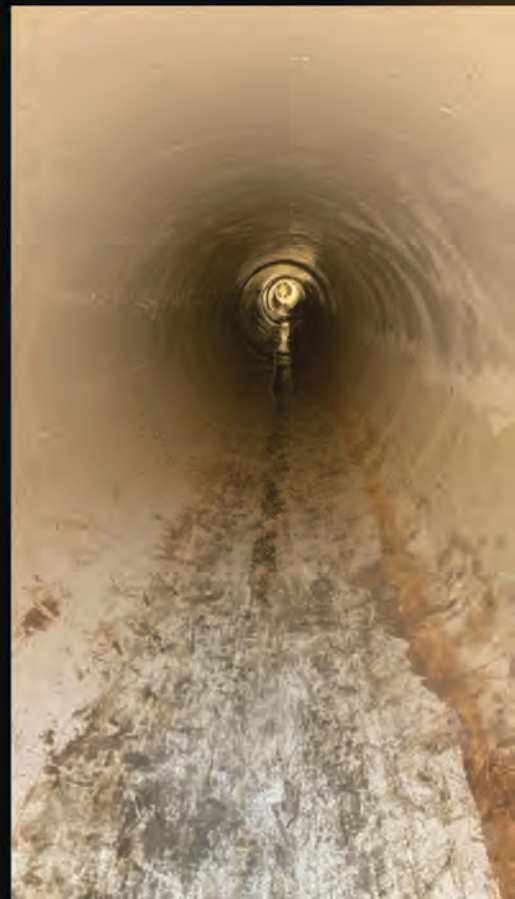
Wallingsford, who has since retired from the City of Lewisville and now works for the Texas Rural Water Association, says he knew the problem was severe if he was being called to the field to decide, noting that his position as maintenance manager was mostly an office position. What he saw was a sinkhole and an exposed 7-ft section of reinforced concrete pipe (RCP).

“When we went to clean the manhole, about half of the concrete in the cast-in-place manhole was gone to the rebar, and about one-third of the rebar was gone,” says Rau.

Two days later, Resinating LLC was back at the landfill with its patented Fiberglass Expansion Liners ready to reline the 80-ft length of 30-in. diameter reinforced concrete pipe. Wallingsford was still skeptical that the flexible fiberglass would be able to make the needed repair without deflections or other issues. Rau reassured him that once Resinating’s proprietary primer and bonding agent were applied and the Resinating Fiberglass Expansion Liners in place, the city would have a perfectly round, structurally sound and leakproof pipe. The project was complete in one day, and to Wallingsford’s surprise and delight, with zero deflections. “Knowing the other methods available, even if there was a slight deflection, I would have been okay, but to have a smooth and leakproof pipe

Both the manhole and pipe rehab processes are the same. The surface is properly cleaned with a pressure washer or jetter truck, the proprietary primer is applied followed by the bonding agent and the fiberglass liners are put in place. If there is a void present, it is identified, and the void is filled using the bonding agent after the fiberglass liner is in place. The emergency repair was complete using 6-ft liners, though liners can be up to 18 ft in length if needed. These lengths will increase when Resinating’s new manufacturing plant opens.

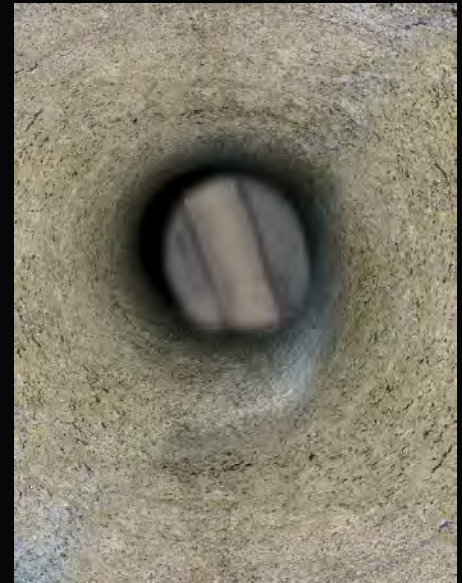
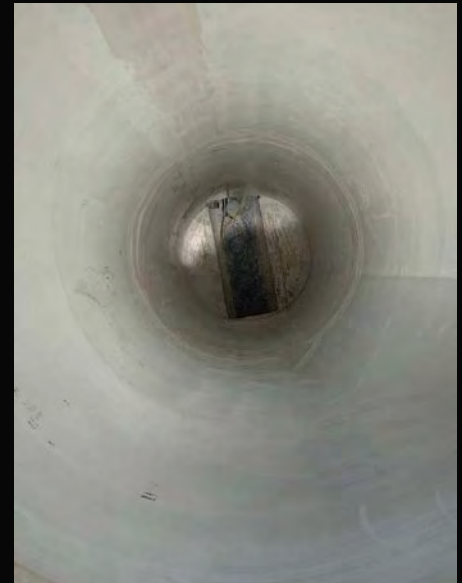
However, everything wasn’t smooth sailing. To help Resinating’s five-man crew access the pipe, the city removed the above-surface corbels for the two manholes on either side of the collapsed pipe. What they found was a severely deteriorated structure, the likes that Wallingsford had never seen before, he was surprised the manhole structures were still standing.

This discovery also gave the department a clue as to what led to the decay and collapse of the pipe and the two deteriorated manholes. Wallingsford and Rau point the blame at a build-up of hydrogen

sulfide (H<sub>2</sub>S). Debris would get stuck on the exposed metal creating an increase in the H<sub>2</sub>S and the two manholes were at the high points on the sewer and the gas would get trapped in the chimney section.

Again, an emergency presented itself, and Rau reassured Wallingsford that the manholes could be repaired using the EIPI Technology. The manholes were cleaned and prepped, and the work took place two days later.
